**Asbestos Survey of  
1009 Monaca RED  
East Liverpool, Ohio**

### **Summary/Site Description**

On May 9, 2026 a survey of 1009 Monaca RED, East Liverpool, OH was performed by J.S. Asbestos Inspections, LLC. The purpose of the asbestos survey was to identify asbestos-containing materials (ACMs) located at the above address prior to demolition activities being performed.

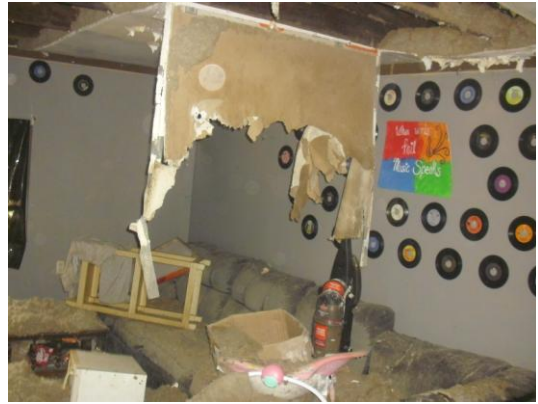
Floor 1 Room 1

| # | HA | Description | FL | Room | Dir/Part | Qty | G/F/P | Friable | |
|---|---|---|---|---|---|---|---|---|---|
| 1 | B | dry wall | 1 | 1 | N WL | 3150 | P | Yes | |
| 6 | C | glaze | 1 | 1 | E win | 6 | F | NO | D-ACOUSTIC TILE |

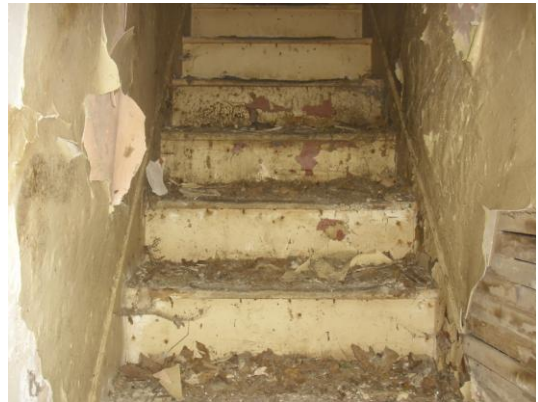
Stairs to Floor 2

| # | HA | Description | FL | Room | Dir/Part | Qty | G/F/P | Friable | |
|---|---|---|---|---|---|---|---|---|---|
| 8 | A | plaster | 2 | stairs | N WL | 432 | P | NO | F-MASTIC |
| 9 | A | plaster | 2 | stairs | S WL | 432 | P | NO | G-9 X 9 TILES |
