**Asbestos Survey of  
1167 Boyd St.  
East Liverpool, Ohio**

Prepared by:

J.S. Asbestos Inspections LLC  
1317 Keefer Rd.  
Girard, Ohio 44420

On April 26, 2026 a survey of 1167 Boyd St., East Liverpool, OH was performed by J.S. Asbestos Inspections, LLC. The purpose of the asbestos survey was to identify asbestos-containing materials (ACMs) located at the above address prior to demolition activities being performed.

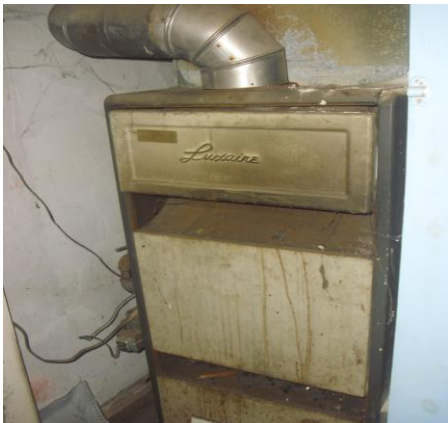
Floor 1 Room 2

| # | HA | Description | FL | Room | Dir/Part | Qty | G/F/P | Friable | |
|---|---|---|---|---|---|---|---|---|---|
| Duct Wrap | | 6 | Fair | | Y | Floor 1 on furnace | | | |
