**Asbestos Survey of  
674 Riley Ave.  
East Liverpool, Ohio**

### **Summary/Site Description**

On April 26, 2026 a survey of 674 Riley Ave., East Liverpool, OH was performed by J.S. Asbestos Inspections, LLC. The purpose of the asbestos survey was to identify asbestos-containing materials (ACMs) located at the above address prior to demolition activities being performed.

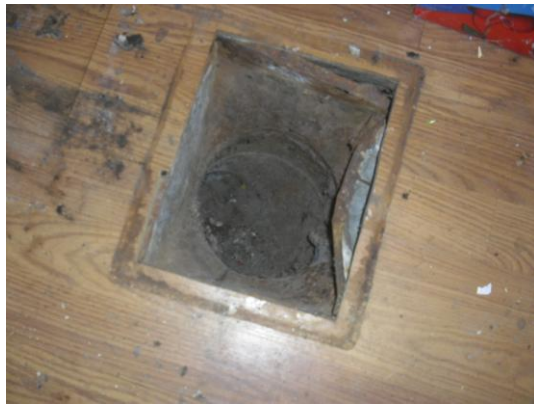
| # | HA | Description | FL | Room | Dir/Part | Qty | G/F/P | Friable | |
|---|---|---|---|---|---|---|---|---|---|
| Registers | | 9 | Fair | Yes | Floor 2 | | | | |

Floor 1 Room 4 Unwrapped Register

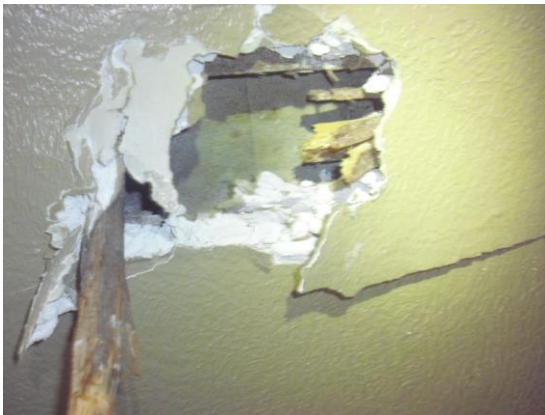
| # | HA | Description | FL | Room | Dir/Part | Qty | G/F/P | Friable | |
|---|---|---|---|---|---|---|---|---|---|
| Risers | | 60 | Fair | Yes | F1 1 Rm 3+4 | | | | |

Floor 1 Room 3 Wrapped Riser
