**Asbestos Survey of  
1066 St. Clair Ave.  
East Liverpool, Ohio**

On April 25, 2026 a survey of 1066 St. Clair Ave., East Liverpool, OH was performed by J.S. Asbestos Inspections, LLC. The purpose of the asbestos survey was to identify asbestos-containing materials (ACMs) located at the above address prior to demolition activities being performed.

JS ASBESTOS SURVERY OF  
1066 St. Clair Ave. East Liverpool, Ohio 43920

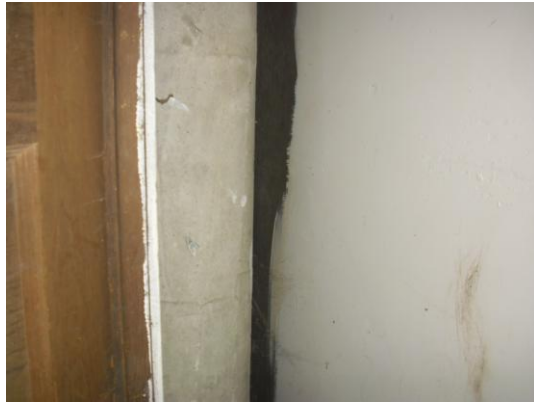
| # | HA | Description | FL | Room | Dir/Part | Qty | G/F/P | Friable | |
|---|---|---|---|---|---|---|---|---|---|
| Risers | | 30 | Fair | | Y | Floor 1 Room 3 | | | |

Floor 1 Room 3 wrapped riser

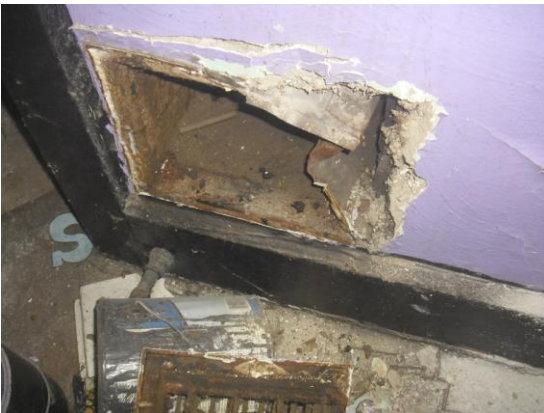
Floor 2 Room 1 unwrapped register

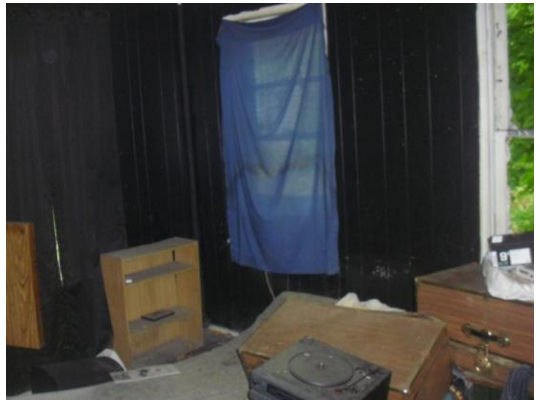
Floor 2 Room 3

| # | HA | Description | FL | Room | Dir/Part | Qty | G/F/P | Friable | |
|---|---|---|---|---|---|---|---|---|---|
| 9X9 Tiles | | 99 | good | | N | Fl 2 Rm 3 Brown | | | |
