**Asbestos Survey of  
1122 St. Clair Ave.  
East Liverpool, Ohio**

On April 25, 2026 a survey of 1122 St. Clair Ave., East Liverpool, OH was performed by J.S. Asbestos Inspections, LLC. The purpose of the asbestos survey was to identify asbestos-containing materials (ACMs) located at the above address prior to demolition activities being performed.

JS ASBESTOS SURVERY OF  
1122 St. Clair Ave. East Liverpool, Ohio 43920

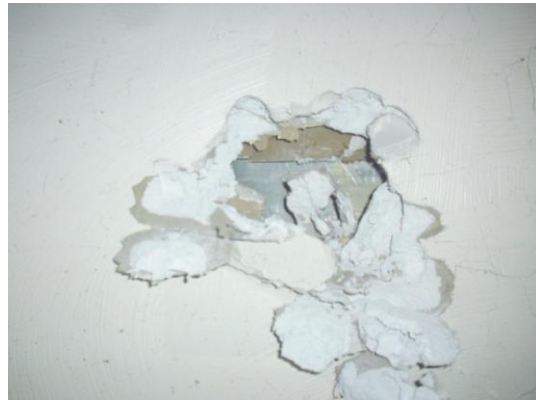
Floor 1 room 2 Unwrapped Riser

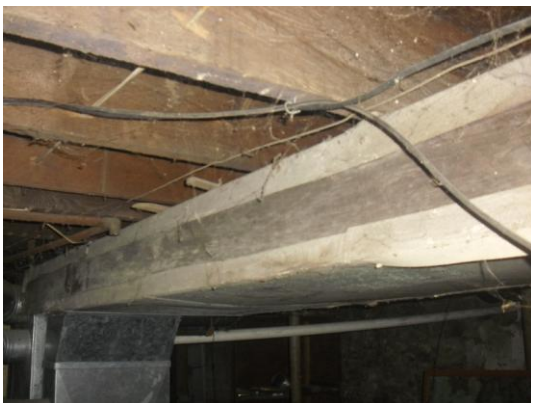
| # | HA | Description | FL | Room | Dir/Part | Qty | G/F/P | Friable | |
|---|---|---|---|---|---|---|---|---|---|
| Duct Wrap | | 15 | Fair | Y | Basement | | | | |

Basement Ducts with Wrap
