**Asbestos Survey of  
1260 Erie St.  
East Liverpool, Ohio**

J.S. Asbestos Inspections LLC  
1317 Keefer Rd.  
Girard, Ohio 44420

Columbiana County Land Reutilization Corporation  
7860 Lincole Place  
Lisbon, Ohio 44432

On April 26, 2026 a survey of 1260 Erie St., East Liverpool, OH was performed by J.S. Asbestos Inspections, LLC. The purpose of the asbestos survey was to identify asbestos-containing materials (ACMs) located at the above address prior to demolition activities being performed.

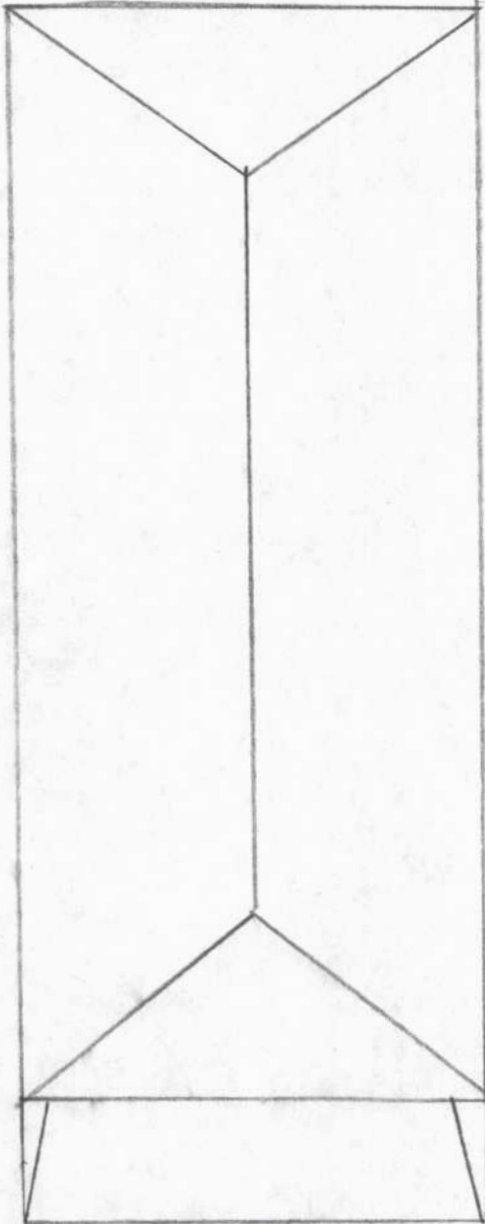
FIELD SURVEY

☒ Collapsed  
☐ Good ☐ Fair ☒ Poor

Unit is fire damaged  
roof is collapsed into  
2nd floor.

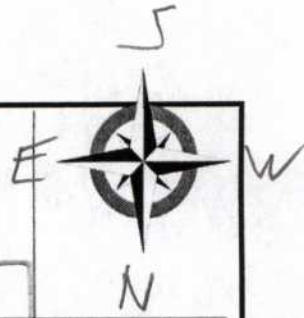
**Second Floor**

1 - ~~Roof~~ Collapsed  
into 2nd Floor

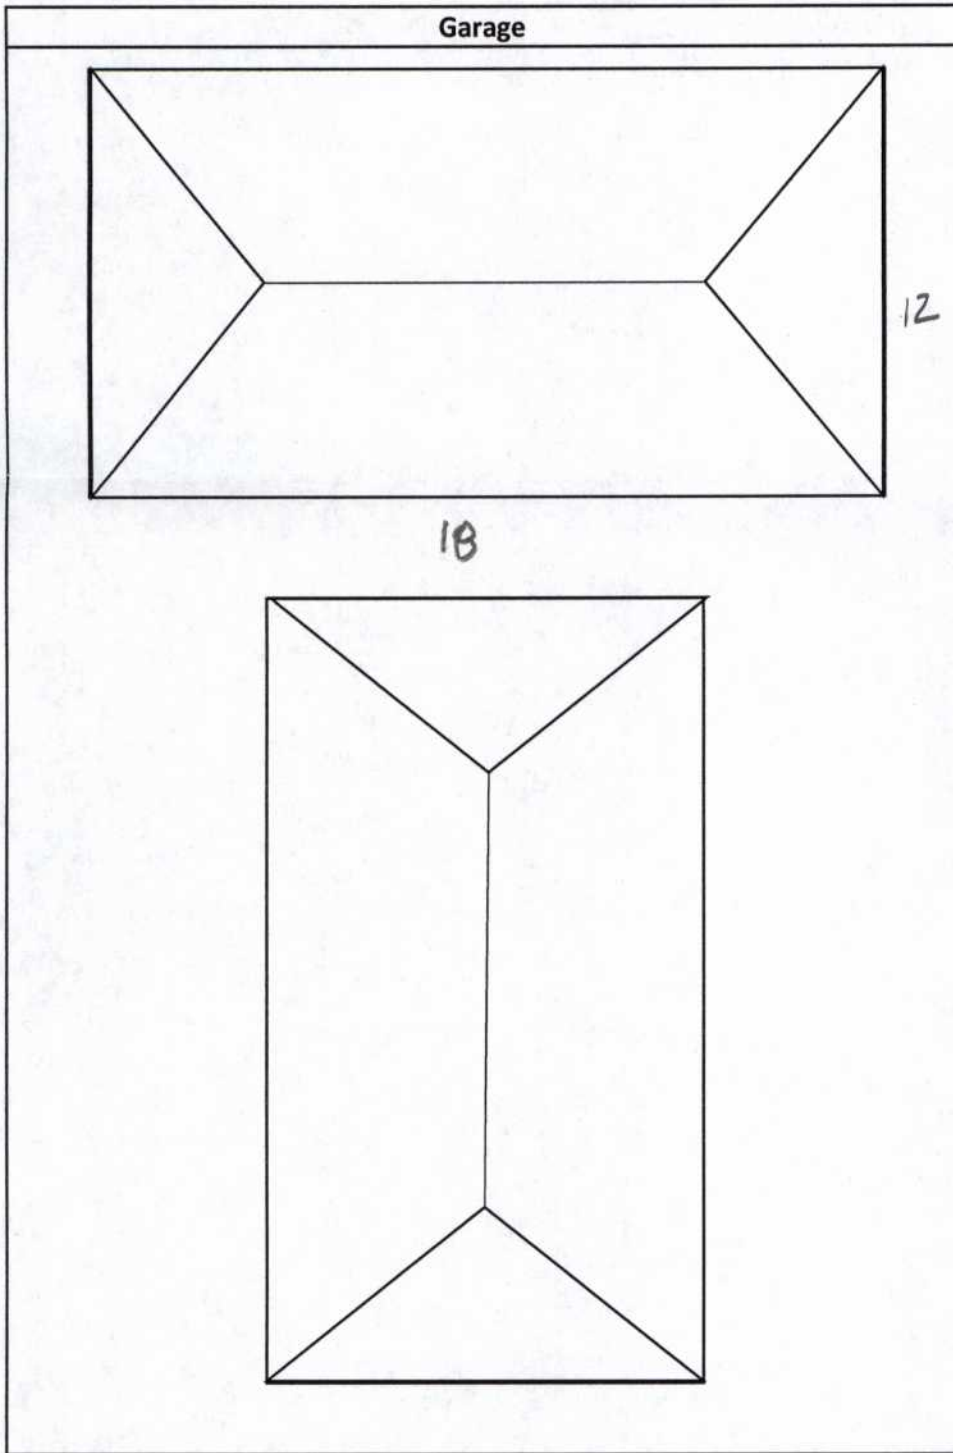
| Dimensions | Width 12 | Length 18 |
| Floor | CN | WD |
| Ceiling | OJ | |
| Interior Walls | OJ | |
| Exterior Walls | WD | |
| Roof | AS | good |

full of tires

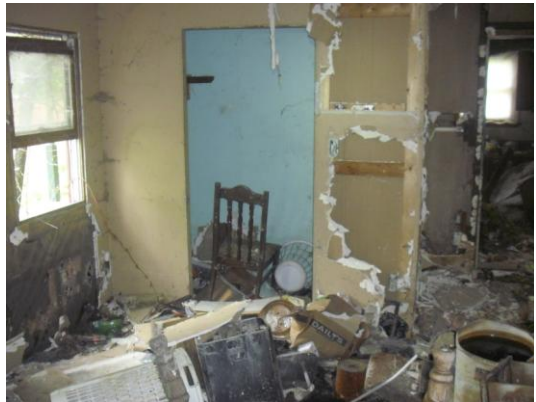
Floor 1 Room 3

| # | HA | Description | FL | Room | Dir/Part | Qty | G/F/P | Friable | |
|---|---|---|---|---|---|---|---|---|---|
| 2 | B | drywall | 1 | 3 | E W L | 4502 | P | yes | HOMOGENOUS AREA (HA) KEY |

| 2<br>G-260428121-616B | (Off-White) Drywall/Floor 1 Room 3 E WL | None Detected | 15% Cellulose | 85% Gypsum | |

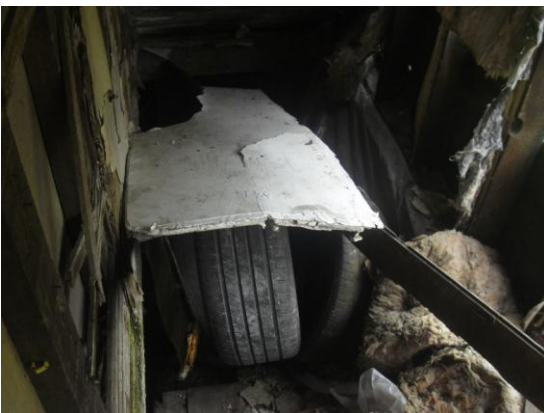
Barricaded Basement Stairs

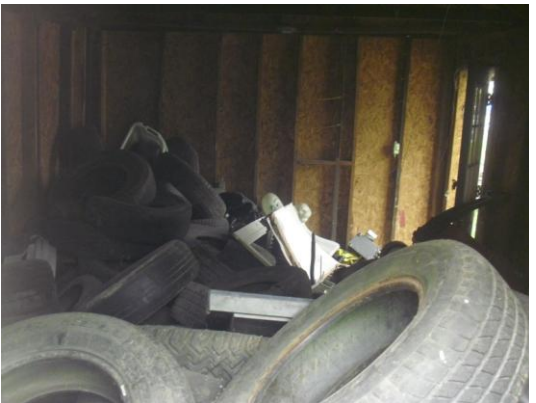
| # | HA | Description | FL | Room | Dir/Part | Qty | G/F/P | Friable | |
|---|---|---|---|---|---|---|---|---|---|
| Asphalt shingle Garage | | 324 | good | N | shed | | | | |

Shed Interior
