**Asbestos Survey of  
149 Thompson Ave.  
East Liverpool, Ohio**

### **Summary/Site Description**

On April 25, 2026 a survey of 149 Thompson Ave., East Liverpool, OH was performed by J.S. Asbestos Inspections, LLC. The purpose of the asbestos survey was to identify asbestos-containing materials (ACMs) located at the above address prior to demolition activities being performed.

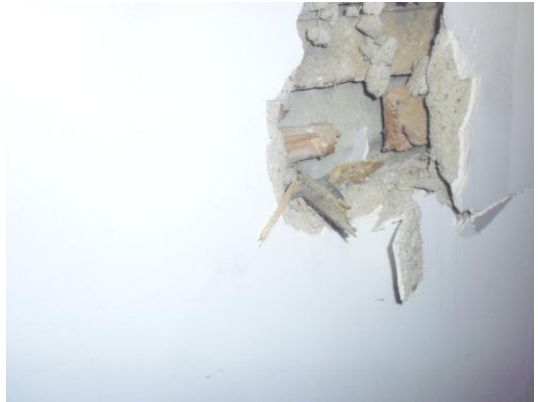
| # | HA | Description | FL | Room | Dir/Part | Qty | G/F/P | Friable | |
|---|---|---|---|---|---|---|---|---|---|
| Risers | | 30 | Fair | Y | Fl 1 Rm 2 | | | | |

Floor 1 Room 2 Wrapped Riser

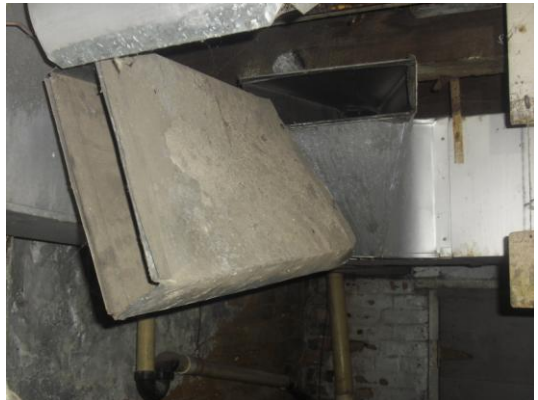
| 17 | Ducts No wrap | 46 |

Basement Ducts No Wrap
