**Asbestos Survey of  
1719 Anderson Blvd.  
East Liverpool, Ohio**

On April 26, 2026 a survey of 1719 Anderson Blvd., East Liverpool, OH was performed by J.S. Asbestos Inspections, LLC. The purpose of the asbestos survey was to identify asbestos-containing materials (ACMs) located at the above address prior to demolition activities being performed.

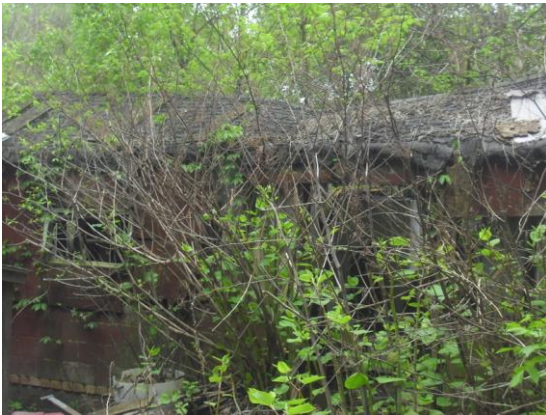
| # | HA | Description | FL | Room | Dir/Part | Qty | G/F/P | Friable | |
|---|---|---|---|---|---|---|---|---|---|
| Asphalt shingle <del>Garage</del> | | 250 | poor | | N | Shed 1 | | | |

| 3 | Shed 1 North Exterior | 32 |

North Shed 1 Exterior

| Material | Location | Category | Quantity | Condition | Friable Y/N |
|---|---|---|---|---|---|
| Asphalt Shingles | Shed I | I | 250 sf | poor | N |

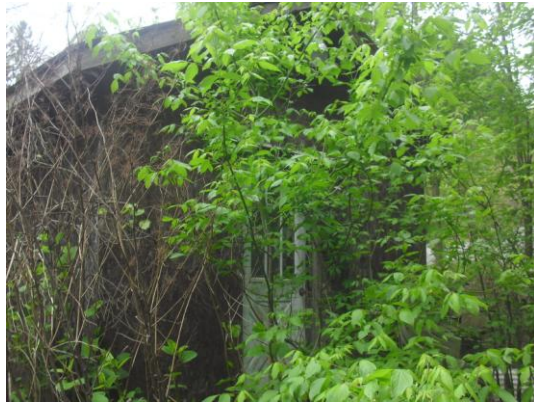
| # | HA | Description | FL | Room | Dir/Part | Qty | G/F/P | Friable | |
|---|---|---|---|---|---|---|---|---|---|
| Asphalt shingles | | 184 | good | | N | Shed 2 | | | |

| 5 | Shed 2 North Exterior | 34 |

North Shed 2 Exterior

| Material | Location | Category | Quantity | Condition | Friable Y/N |
|---|---|---|---|---|---|
| Asphalt Shingles | Shed 2 | I | 184 sf | good | N |

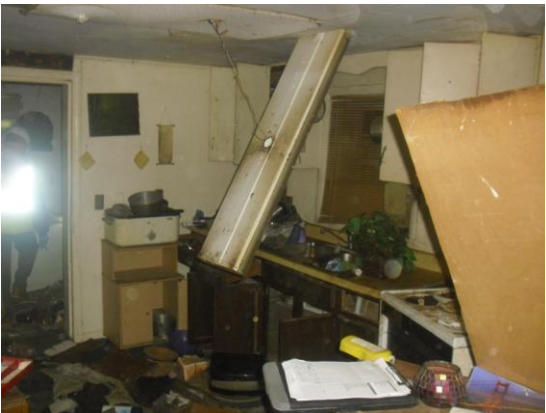
Floor 1 Room 2

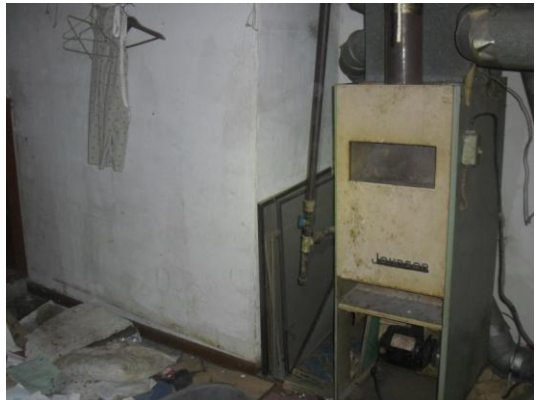
Floor 1 Room 4 Furnace

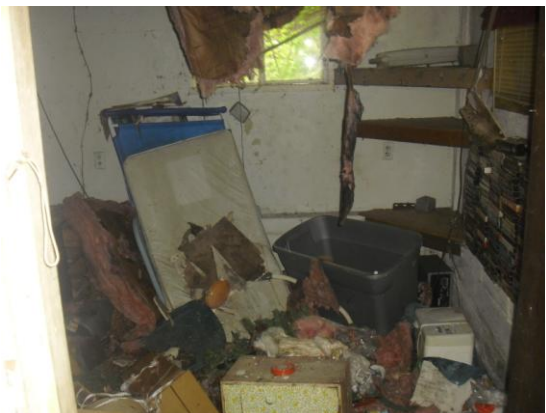
Floor 1 Room 6

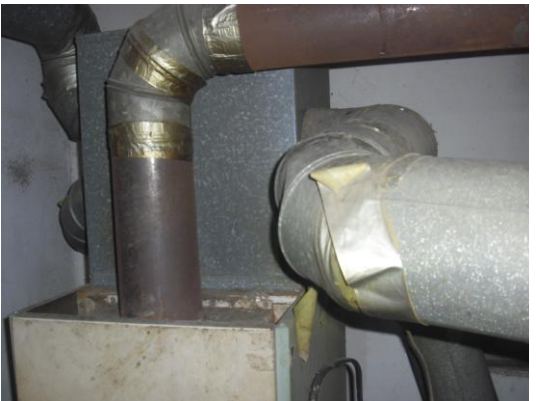
| # | HA | Description | FL | Room | Dir/Part | Qty | G/F/P | Friable | |
|---|---|---|---|---|---|---|---|---|---|
| Duct Wrap | | - | | | | | | | |

| 14 | Floor 1 Room ducts no wrap | 43 |

Ducts on Furnace No Wrap
