**Asbestos Survey of  
188 Beechwood St.  
East Liverpool, Ohio**

On April 25, 2026 a survey of 188 Beechwood St., East Liverpool, OH was performed by J.S. Asbestos Inspections, LLC. The purpose of the asbestos survey was to identify asbestos-containing materials (ACMs) located at the above address prior to demolition activities being performed.

JS ASBESTOS SURVERY OF  
188 Beechwood St. East Liverpool, Ohio 43920

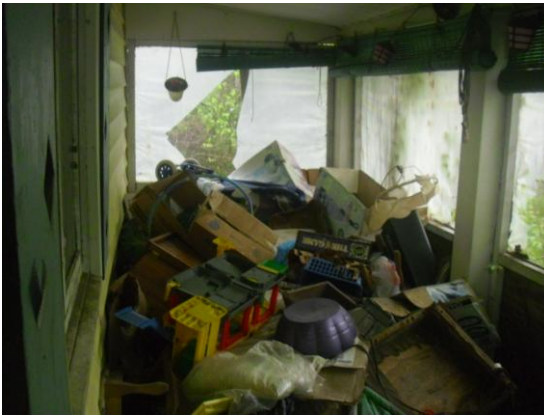
Floor 1 Room 1

| <b>1</b><br>G-260428169-864A | (Off-White) Plaster/Floor 1 Room 1 CL | <b>None Detected</b> | 2% Cellulose | 98% Gypsum |

| <b>10</b><br>G-260428169-873A | (Gray) Window Glazing/Floor 1 Room 1 W WIN | <b>POSITIVE STOP</b> | | |
| <b>11</b><br>G-260428169-874A | (Gray) Window Glazing/Floor 1 Room 1 W WIN | <b>POSITIVE STOP</b> | | |

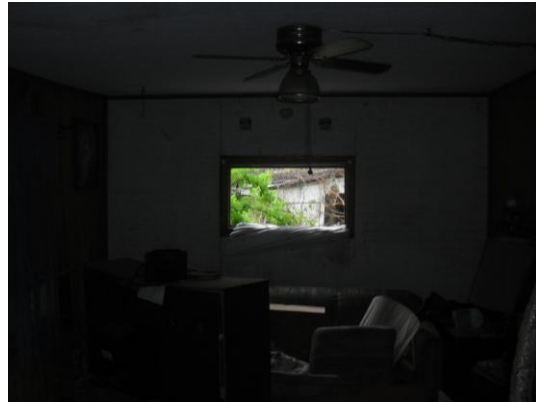
Floor 1 Room 4

| <b>2</b><br>G-260428169-865A | (Off-White) Plaster/Floor 1 Room 4 CL | <b>None Detected</b> | 5% Cellulose | 95% Gypsum |

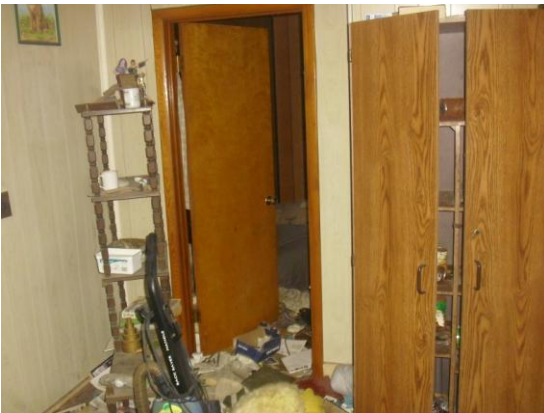
Floor 1 Room 5

| <b>13</b><br>G-260428169-876A | (Off-White) Plaster/Floor 1 Room 5 CL | <b>None Detected</b> | 2% Cellulose | 98% Gypsum |

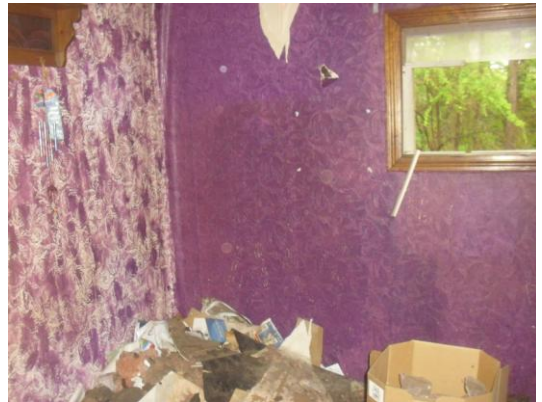
| <b>6</b><br>G-260428169-869A | (Gray) Plaster/Floor 1 Room 8 W WL | <b>None Detected</b> | 2% Cellulose | 98% Gypsum |
| <b>7</b><br>G-260428169-870A | (Gray) Plaster/Floor 1 Room 8 CL | <b>None Detected</b> | 2% Cellulose | 98% Gypsum |
| <b>8</b><br>G-260428169-871A | (Gray) Plaster/Floor 1 Room 8 N WL | <b>None Detected</b> | 2% Cellulose | 98% Gypsum |

| HA | Sample # | Material | Location | Quantity | Condition | Friable Y/N | Asbestos Results |
|---|---|---|---|---|---|---|---|
| A1 | 6-8 | Plaster | Floor 1 Room 8 | 419 sf | Poor | Y | ND |
