JS ASBESTOS SURVERY OF  
838 Lisbon St. East Liverpool, Ohio 43920

**Asbestos Survey of  
838 Lisbon St.  
East Liverpool, Ohio**

### **Summary/Site Description**

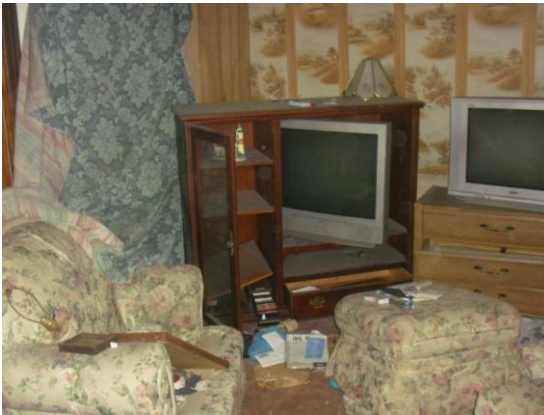
Floor 1 Room 1

| HA | Sample # | Material | Location | Quantity | Condition | Friable Y/N | Asbestos Results |
|---|---|---|---|---|---|---|---|
| B | 4-6 | Drywall | Fl 1 Rms 1 CL | 156 sf | good | Y | ND |

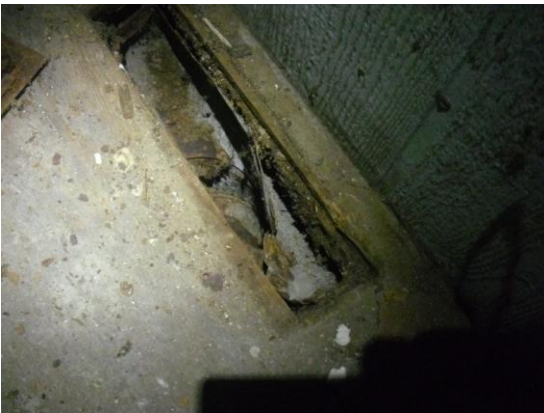
Floor 1 Room 4 Unwrapped Register

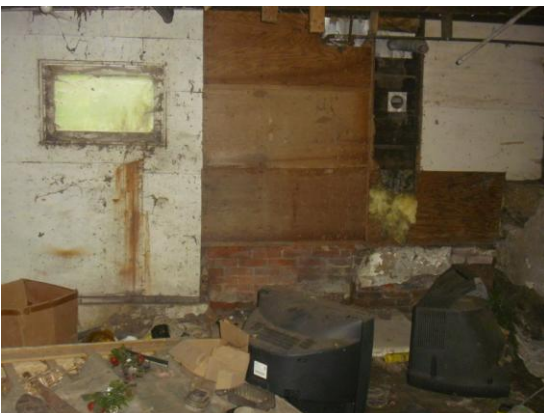
Basement

| Ducts Wrapped | <input checked="" type="checkbox"/> | Yes | No | <i>30</i> Sq. Ft. |

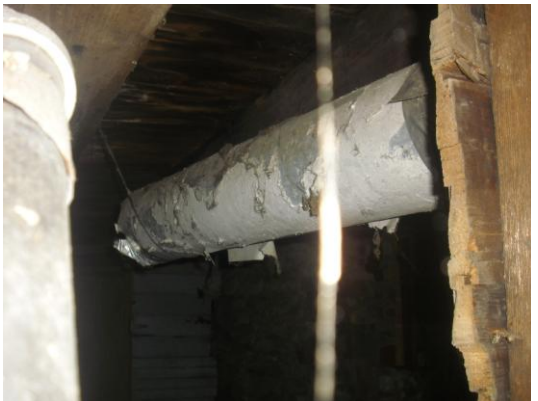
| # | HA | Description | FL | Room | Dir/Part | Qty | G/F/P | Friable | |
|---|---|---|---|---|---|---|---|---|---|
| Duct Wrap | | 30 | Fair | Y | Basement | | | | |

Basement Pipe with Wrap

| Material | Location | Category | Quantity | Condition | Friable Y/N |
|---|---|---|---|---|---|
| Duct Wrap | Basement | friable ACM | 30 sf | fair | Y |

Prior to demolition, contractor(s) working at this structure must be notified of the presence of any building materials identified as containing asbestos or assumed to contain asbestos. Any disturbance of building materials identified as containing less than or equal to 1% asbestos are required to be in compliance with the applicable section of the Occupational Safety and Health Administrations (OSHA's) Asbestos Standard for the Construction Industry. Contractors disturbing any building material identified as containing greater than 1% asbestos or any building material assumed to contain asbestos are required to conduct their activities in accordance with all applicable sections of OSHA's Asbestos Standard as well as applicable EPA NESHAP and Ohio Environmental Protection Agency (OEPA) regulations.

A "Notification of Demolition and Renovation/Abatement" form must be submitted to the Ohio EPA ten (10) days prior to abatement activities being performed which will disturb 50 square feet or 50 linear feet of a friable ACM.
